Home Inspection Report

5409 Tourmaline Drive

Clay, NY 13041

Inspected on Wed, Mar 28 2018 at 3:00 PM

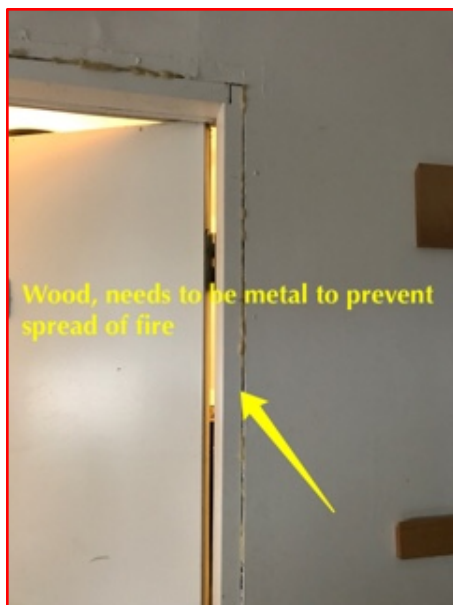
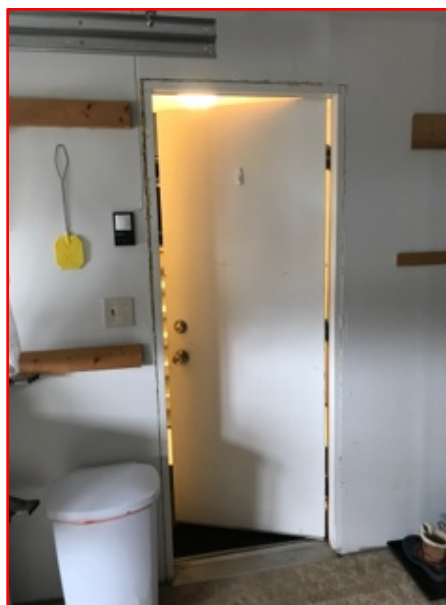
Figure 13-1

1) Safety: The wall between the garage and the house is not fire rated. Although most of the precautions seem to be present, the door casing is made of wood. Recommend installing a metal casing to properly encapsulate the garage.

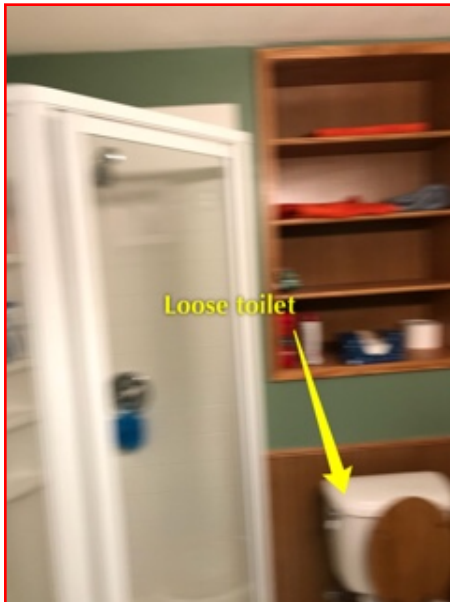
Figure 16-1

2) Repair: Toilet appears to be loose. This may be from a loose anchor bolt, a missing or broken seal, or damage to the subfloor from a leak. Recommend having a qualified person repair as necessary.

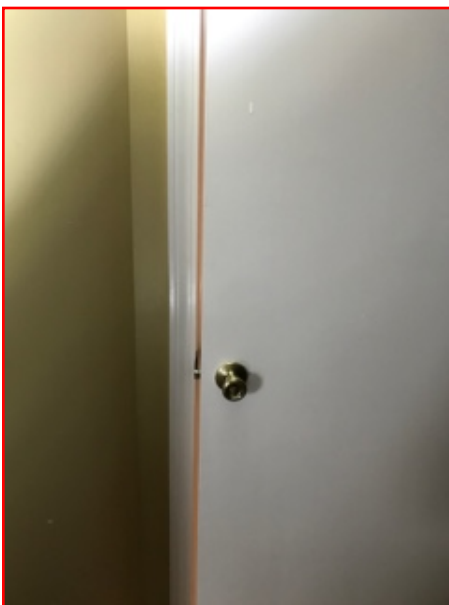
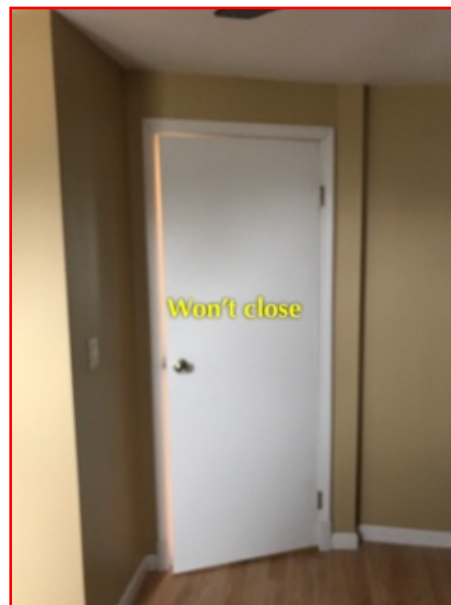
Figure 18-1

3) Repair: Door to master bedroom does not properly latch. It appeared to be catching on the floor trim underneath the door. Recommend having this repaired.

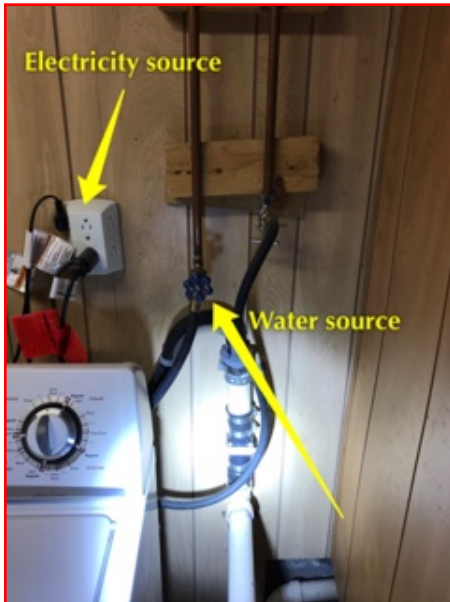
Figure 20-1

4) Safety: Outlet is in close proximity to water lines. This is a potential issue if the water lines were to burst, and water came in contact to outlet. Recommend moving the outlet further up and away on the wall.

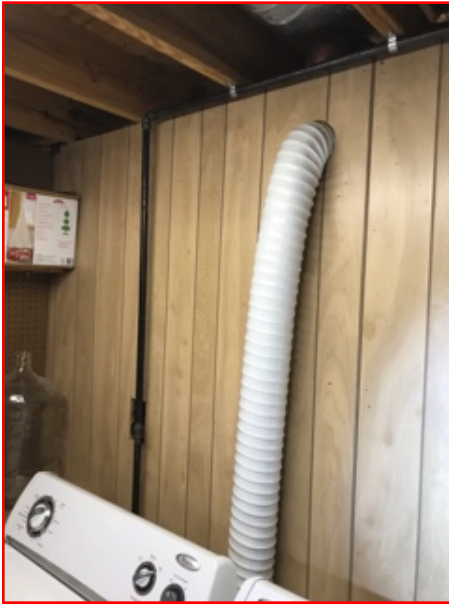
Figure 21-1

5) Safety: The dryer is not properly vented to the exterior of the house, as it vents out too far up the wall, preventing any solid materials (such as lint) the ability to escape. Moisture and lint can accumulate and create safety issues. Recommend having a qualified person repair as necessary.

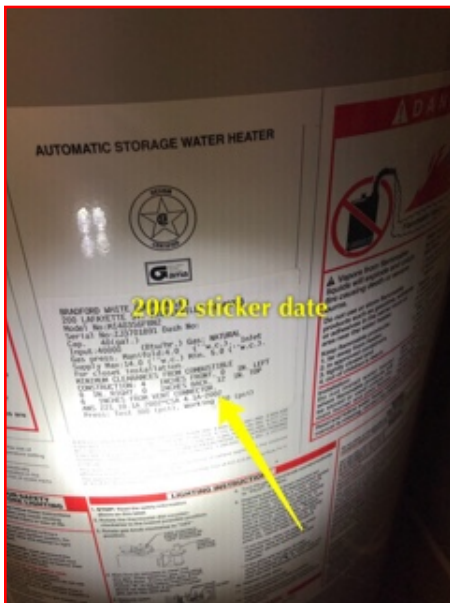
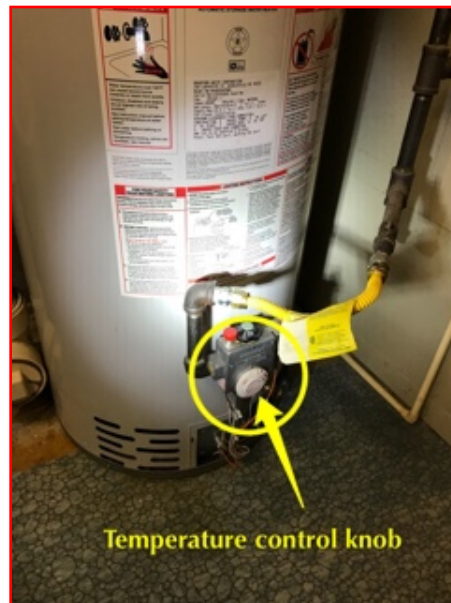
Figure 24-1

6) Monitor: The hot water heater has an ANSI (manufactured) sticker date of 2002. Standard tank water heaters generally have a life expectancy of 7-10 years. Although it operated well on the day of the inspection, this unit can fail at any time. Recommend budgeting for a replacement.

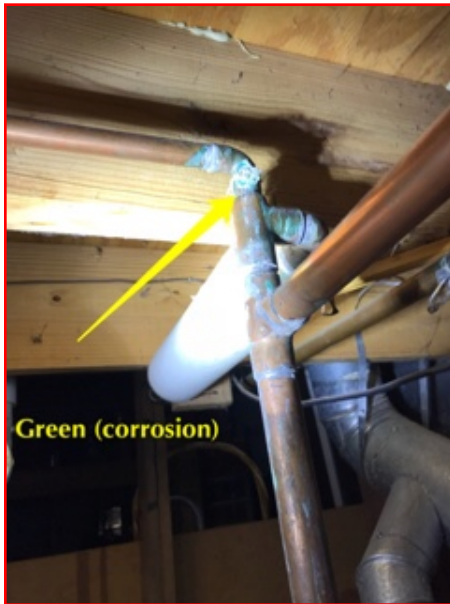
Figure 26-1

7) Repair: corrosion noted around copper plumbing supply line fittings. This may be the result of non-compatible metal fittings or perhaps a lead-based flux material to secure the fittings. In any case, this corrosion will eventually lead to leakage. Recommend having it repaired. No leaks noted on day of the inspection.

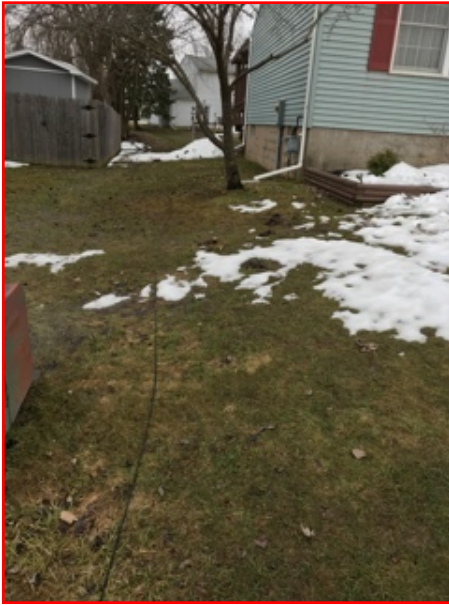
Figure 30-1

9) Safety: Exposed electrical wire present outside in the front lawn. This is a safety hazard. Recommend having the wire moved or dug below ground.

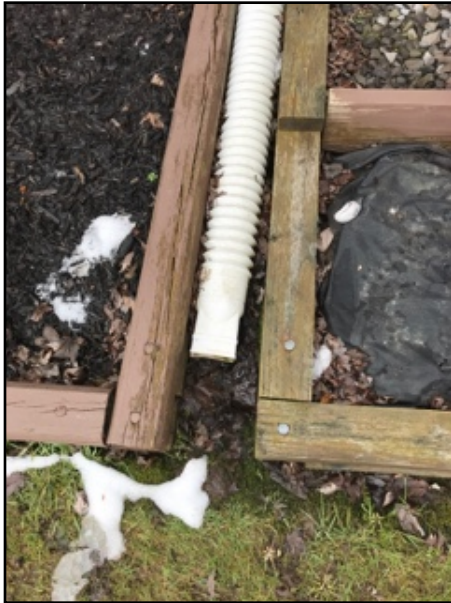
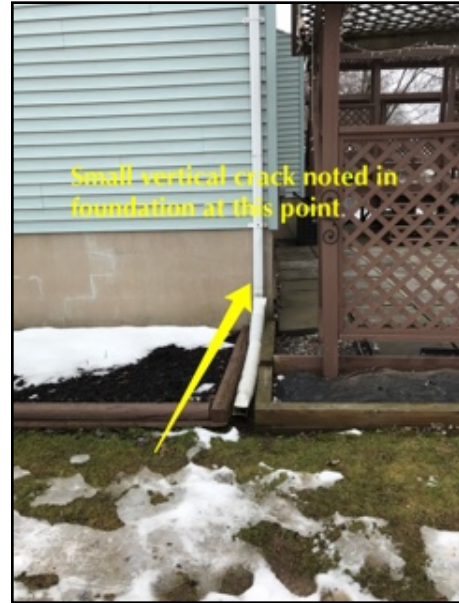
Figure 5-1

Comment: Flex pipe gutter extension on the west side of the house is noted, but does not appear to be long enough. Recommend extending the gutter extension out an additional 3 feet to carry rain water away from the foundation.

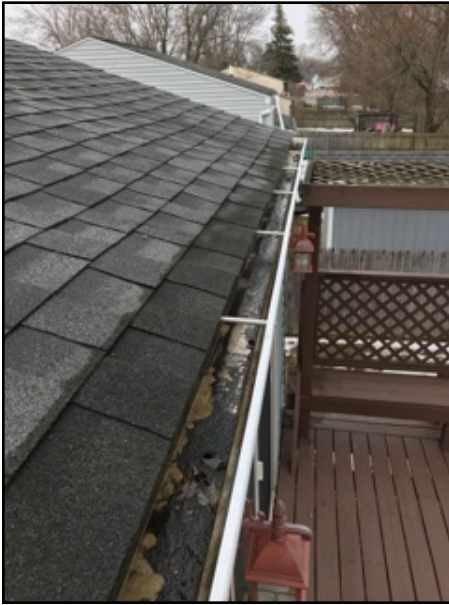
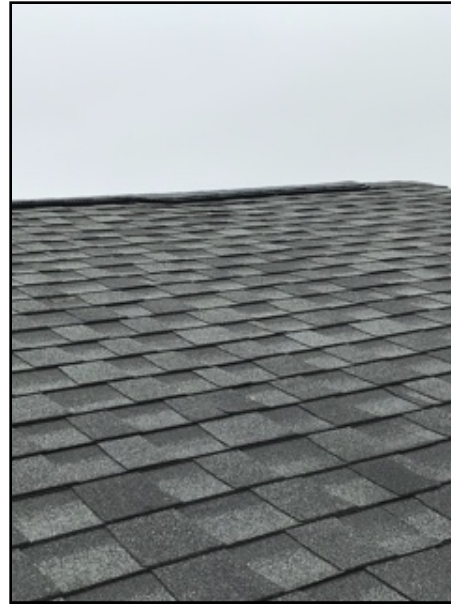
Figure 6-1

General picture: no debris in gutters and shingles appear to be in generally good condition.

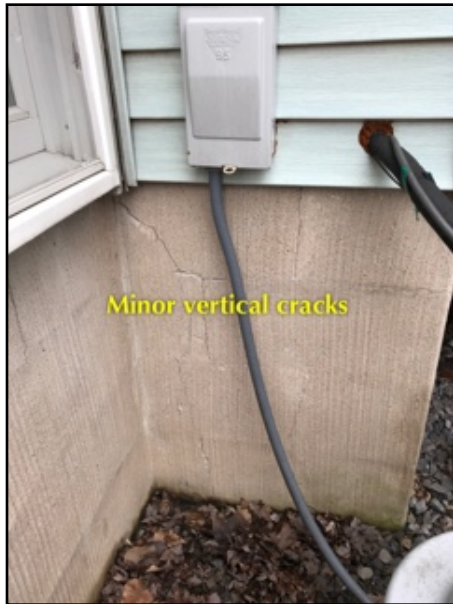
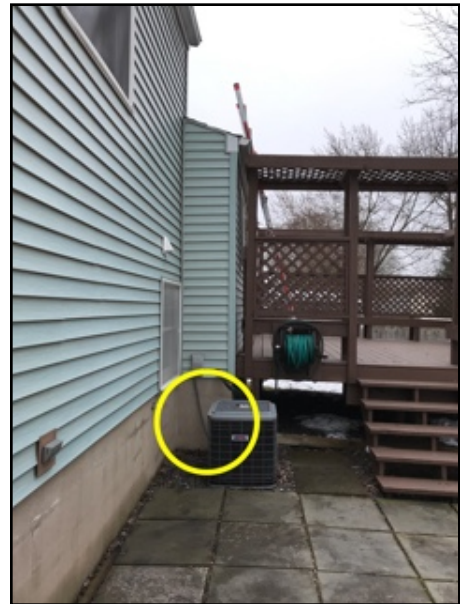
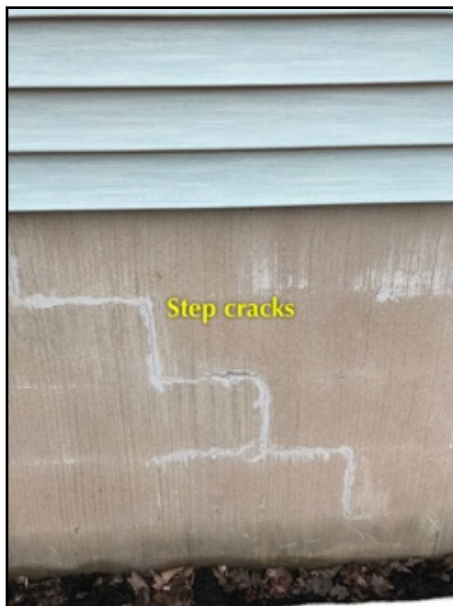
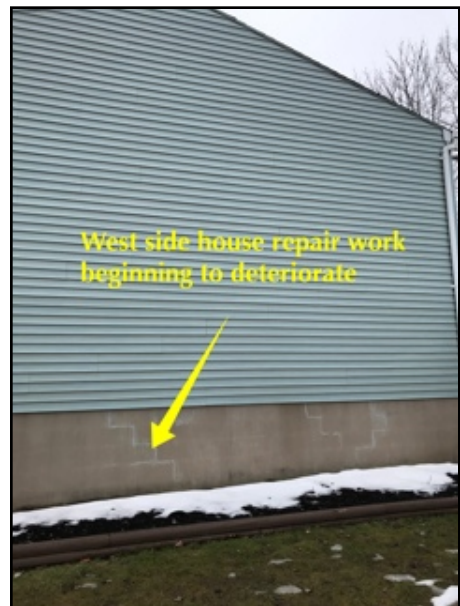
Figure 7-1

Repair: minor step cracks and vertical cracks are noted around foundation exterior. This can allow for moisture intrusion, which may exacerbate the issue. Recommend sealing these cracks with an approved concrete repair substance, such as acrylic caulk or mortar. Foundation cracks tend to become troublesome once they reach 1/4" width, your cracks were generally less than 1/8".

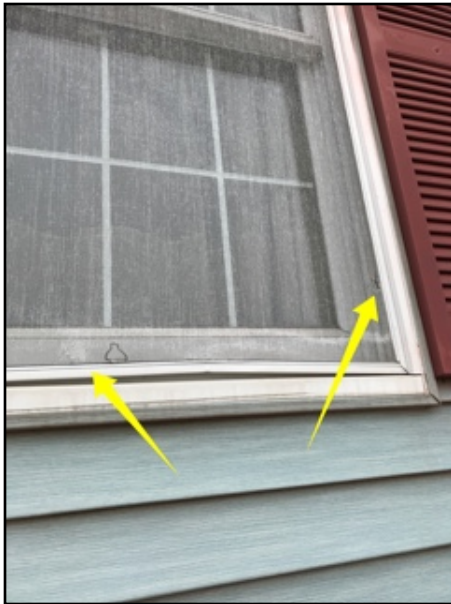
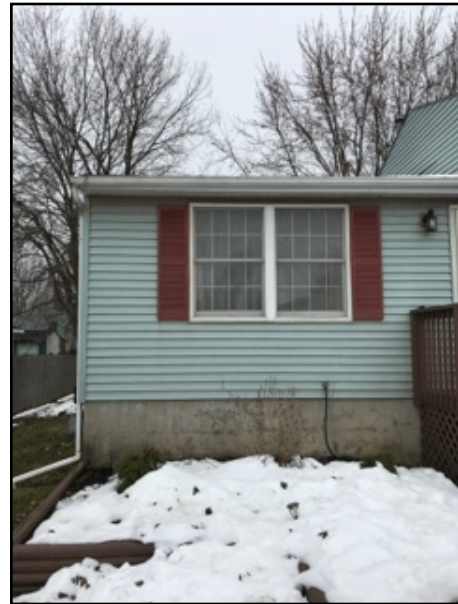
Figure 8-1

Repair: minor damage to screen on north side of house. This serves as an entry point for insects to get into the home. Recommend replacing the screen or using a screen patch.

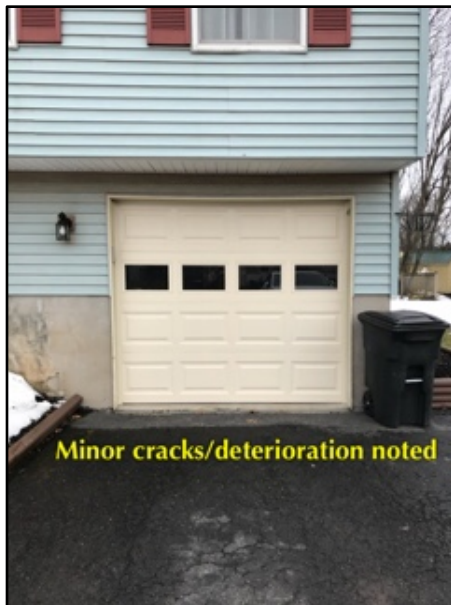
Figure 9-1

Repair: Recommend resealing the driveway to cover the cracks and prevent worsening.

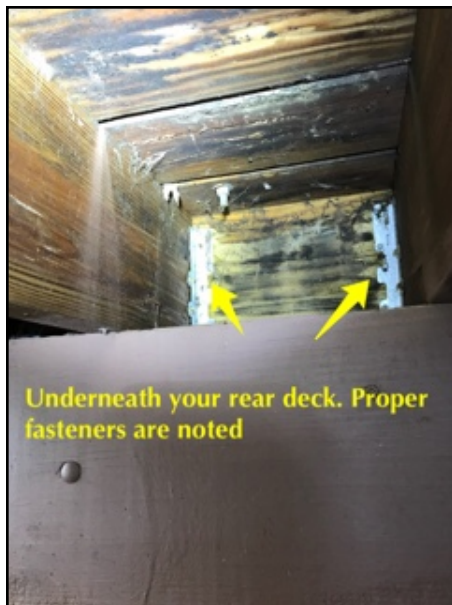
Figure 12-1

General picture of the fasteners used under rear deck.

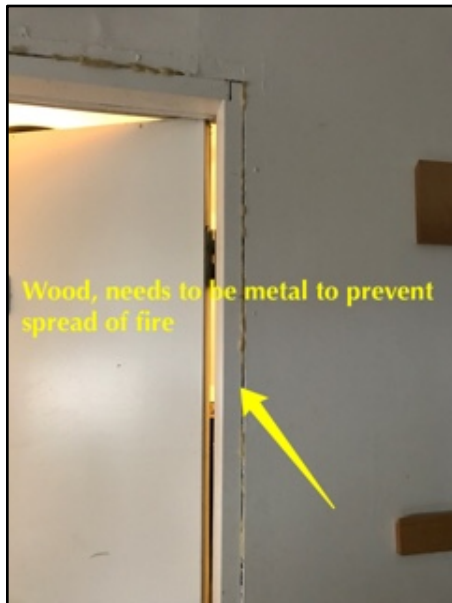
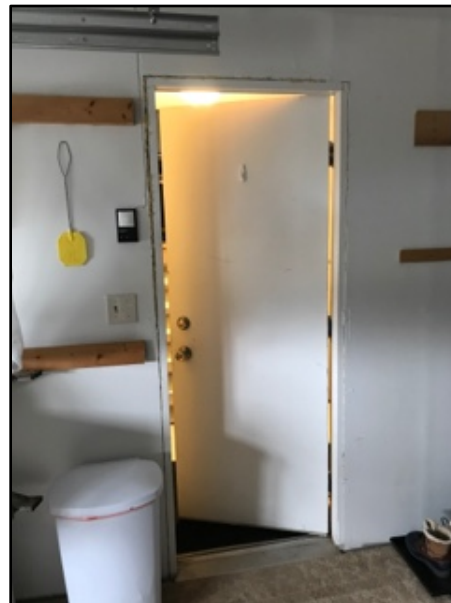
Figure 13-1

Safety: The wall between the garage and the house is not fire rated. Although most of the precautions seem to be present, the door casing is made of wood. Recommend installing a metal casing to properly encapsulate the garage.

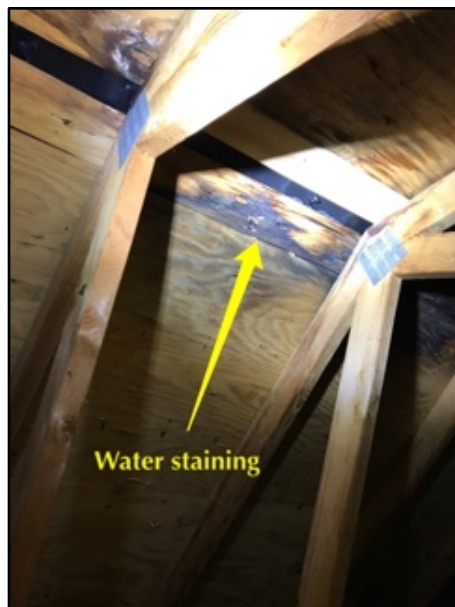
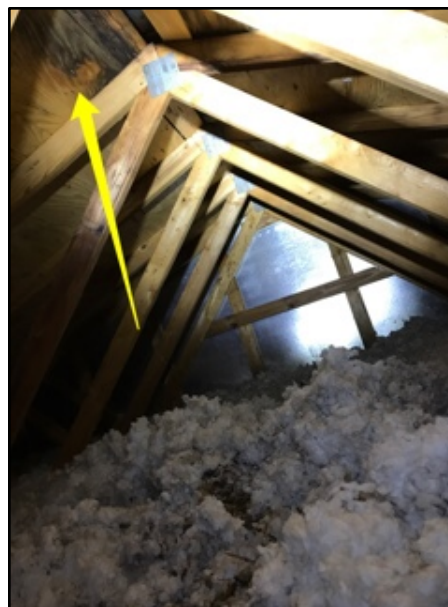
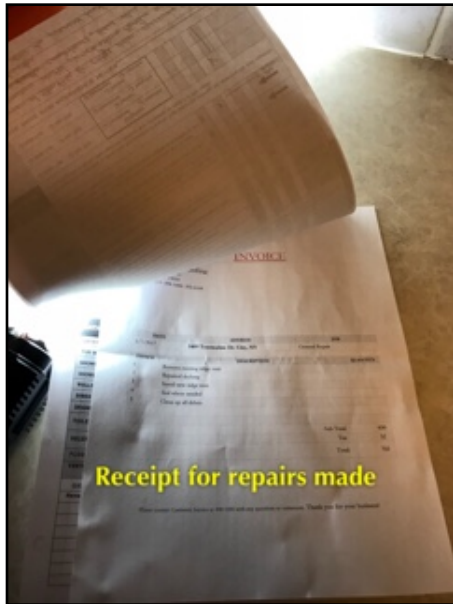
Figure 14-1

Monitor: Water staining and overall indicators of water intrusion are present throughout the attic and on some portions of the ceiling. Although this is normally a considered a deficiency, the stains do not appear to be "fresh" and there was a receipt on the counter noting repairs made back in May. I recommend you monitor it for worsening and repair if needed.

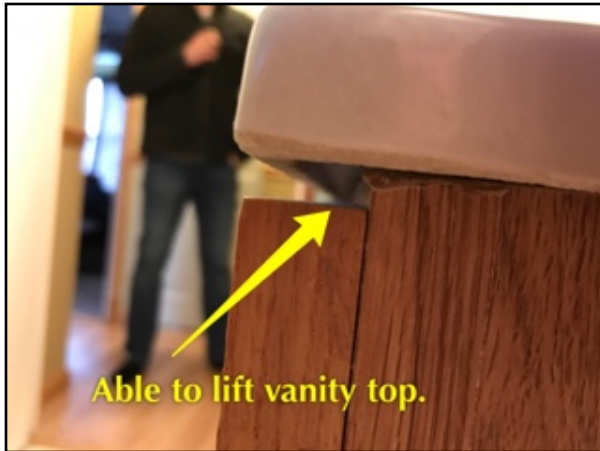
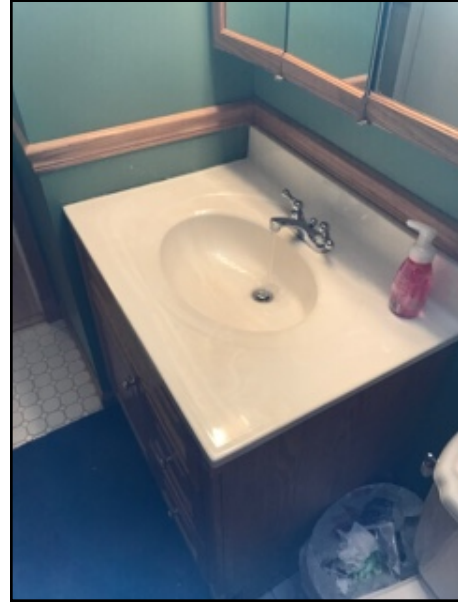
Figure 15-1

Repair: Vanity sink top is loose. Recommend securing the vanity top with a properly rated adhesive.

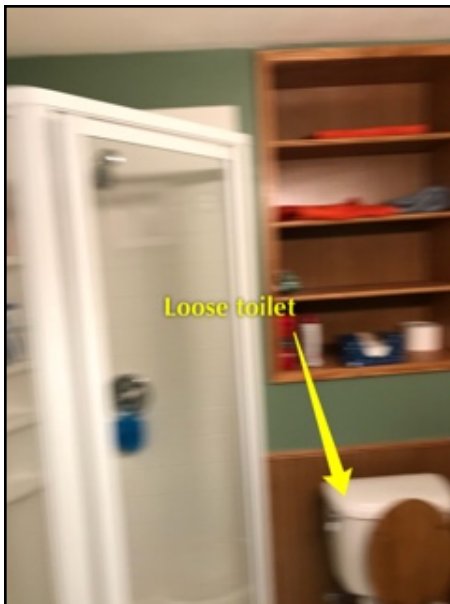
Figure 16-1

Repair: Toilet appears to be loose. This may be from a loose anchor bolt, a missing or broken seal, or damage to the subfloor from a leak. Recommend having a qualified person repair as necessary.

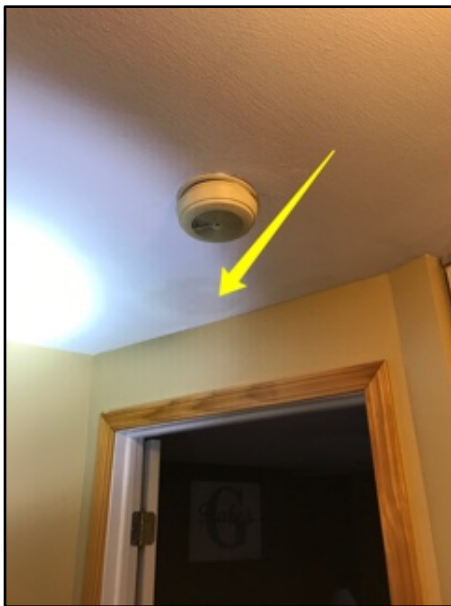
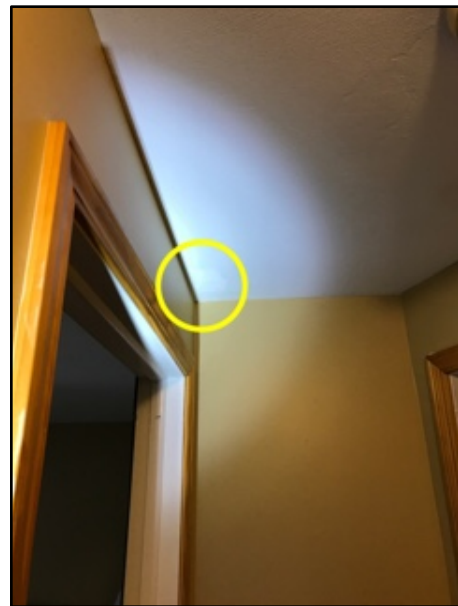
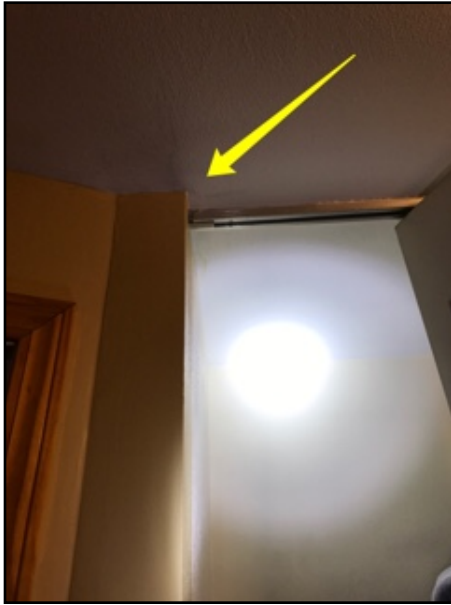
Figure 17-1

Monitor: Indications of prior water staining present on ceilings throughout the house. Recommend monitoring for worsening.

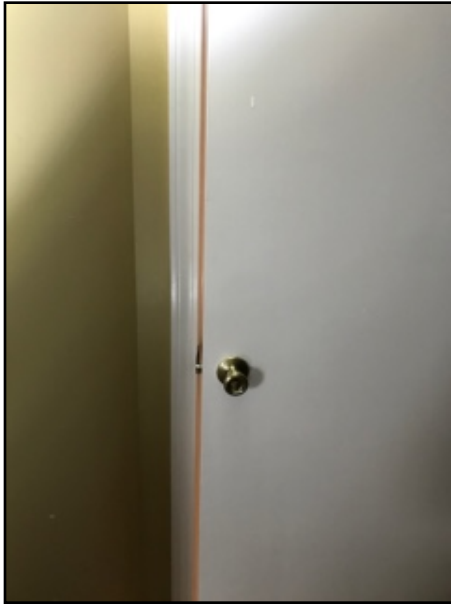
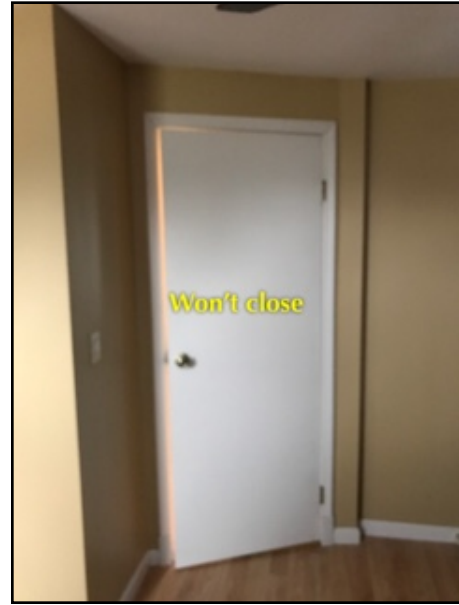
Figure 18-1

Repair: Door to master bedroom does not properly latch. It appeared to be catching on the floor trim underneath the door. Recommend having this repaired.

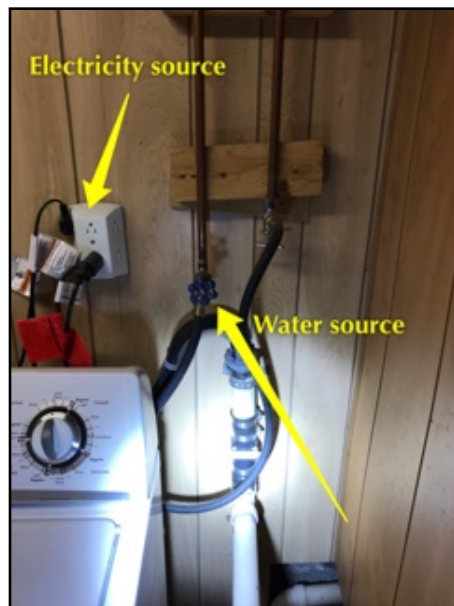
Figure 20-1

Safety: Outlet is in close proximity to water lines. This is a potential issue if the water lines were to burst, and water came in contact to outlet. Recommend moving the outlet further up and away on the wall.

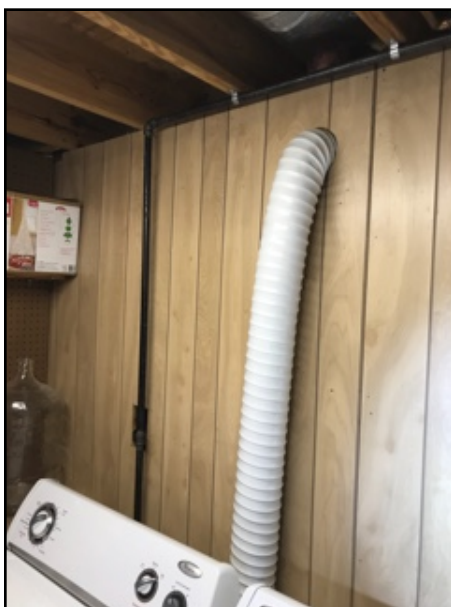
Figure 21-1

Safety: The dryer is not properly vented to the exterior of the house, as it vents out too far up the wall, preventing any solid materials (such as lint) the ability to escape. Moisture and lint can accumulate and create safety issues. Recommend having a qualified person repair as necessary.

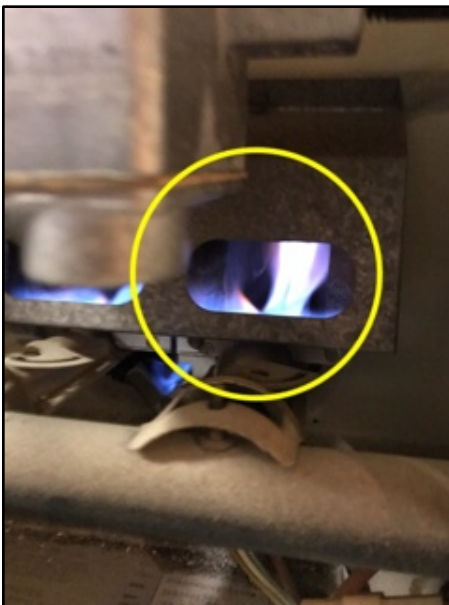
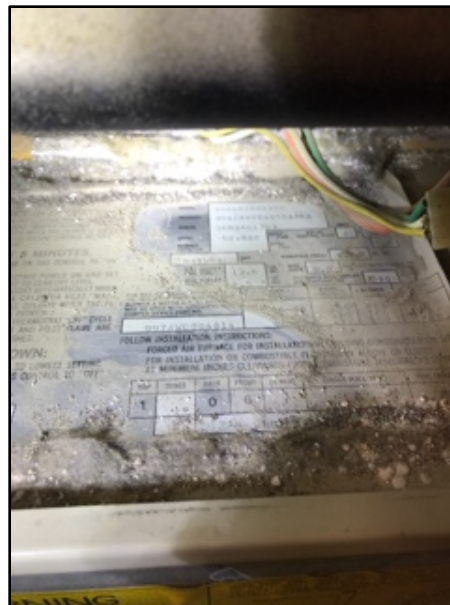
Figure 23-1

General picture: Good, consistent flame noted.

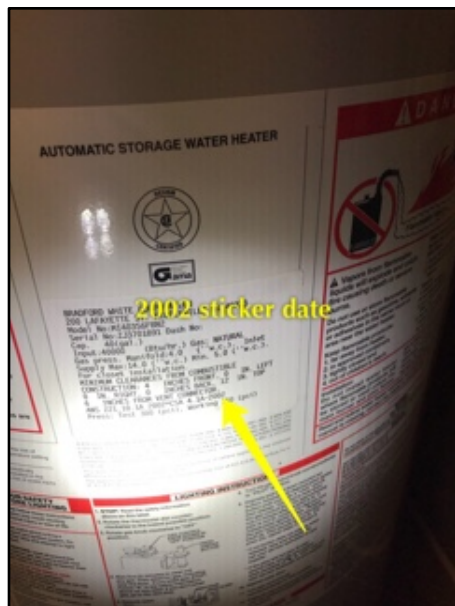
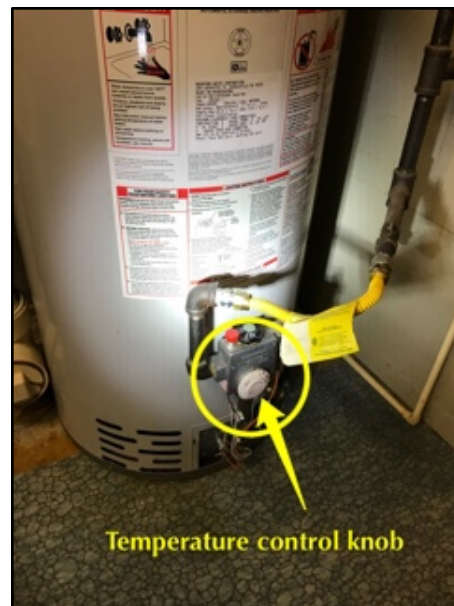
Figure 24-1

Monitor: The hot water heater has an ANSI (manufactured) sticker date of 2002. Standard tank water heaters generally have a life expectancy of 7-10 years. Although it operated well on the day of the inspection, this unit can fail at any time. Recommend budgeting for a replacement.

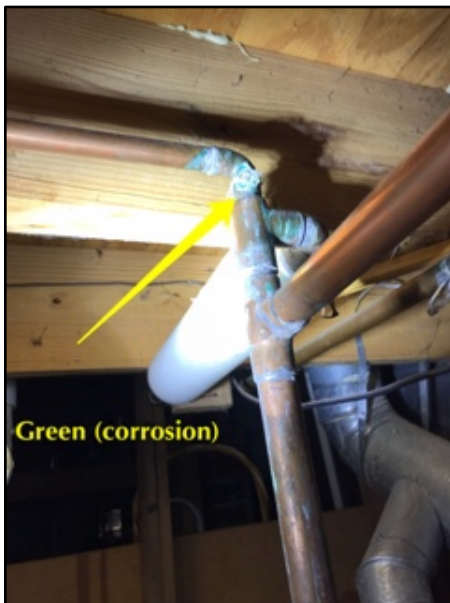
Figure 26-1

Repair: corrosion noted around copper plumbing supply line fittings. This may be the result of non-compatible metal fittings or perhaps a lead-based flux material to secure the fittings. In any case, this corrosion will eventually lead to leakage. Recommend having it repaired. No leaks noted on day of the inspection.

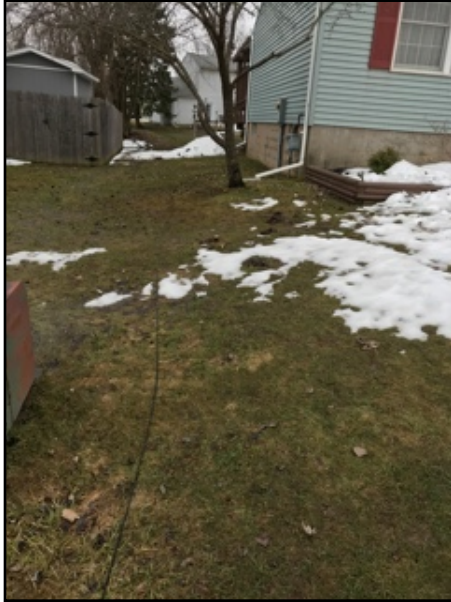
Figure 30-1

Safety: Exposed electrical wire present outside in the front lawn. This is a safety hazard. Recommend having the wire moved or dug below ground.
